Investigating post-fracture surfaces at the nanometer scale in the Smartcut™ technology

EXTENDED ABSTRACT

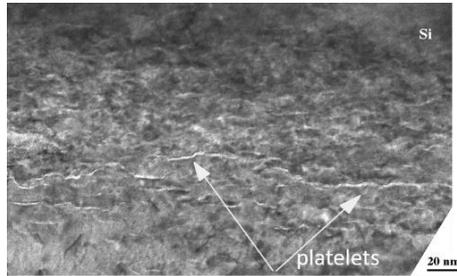
Figure 1 : TEM image of the platelets inside Silicon after Hydrogen implantation. From [6]

The ion implantation using high doses of light elements (H or He) in silicon substrates leads to the formation of a buried damaged layer which contains various crystalline defects ranging from point defects, vacancies/interstitials-hydrogen complexes and nanometric cavities filled with gas, named “platelets”. At the depth of maximum damage, the mechanical stress due to the strained Silicon lattice promotes the development of (100) platelets, parallel to the wafer surface [1]. Upon annealing, platelets grow via an Ostwald Ripening mechanism [2], which modifies their distribution inside Silicon. Eventually, coalescences among neighbours definitively set the opened surface and microcracks appear [3]. When the implanted substrate is bonded to another one, the latter acts as a stiffener and microcracks keep growing until a fracture propagates through the bonded structure. The SmartCut™ technology takes advantage of this effect to transfer a thin Silicon layer on top of an oxidized Silicon substrate, which yields the Silicon-on-insulator (SOI) [4]. Because advanced devices keep requiring better thickness uniformity of the thin transferred Silicon layer, an accurate assessment of the post-transfer roughness and its origin is of great interest. Especially, the ion implantation conditions are a key parameter that controls the distribution of platelets after implantation[5], and hence the post-transfer surface. In this paper, a simple model is proposed to describe the post-fracture surface thanks to a characterization performed using Atomic Force Microscopy (AFM).

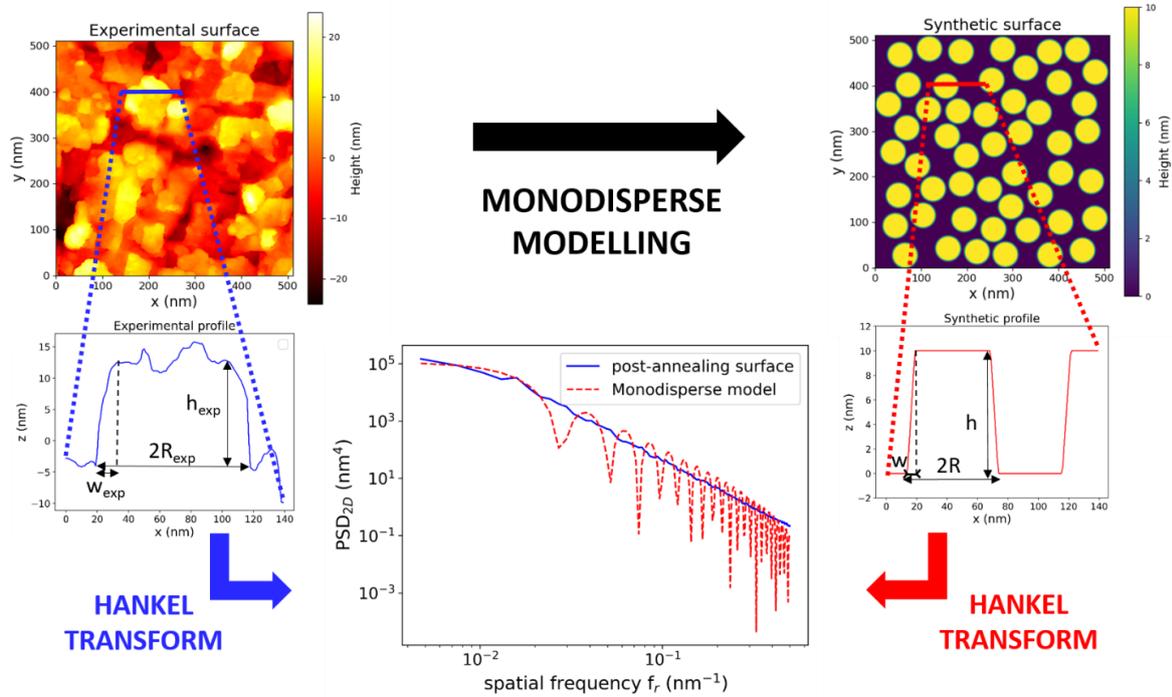
Figure 2 : Scheme used to compute the parameters of the post-annealing surface patterns

Wafer implanted with several implantation conditions were bonded to a Silicon substrate (stiffener) and the whole structure was annealed until fracture occurred. Post-fracture surfaces were characterized by AFM in Peak-Force mode, using a super sharp probe (2 nm radius). The scans were then investigated through spectral analysis, using the 2D Power Spectral Density (PSD). The PSD signals were fitted with a simple three-parameter model which yields the size, height and width of equivalent surface patterns. The validity of this model was established on surfaces exhibiting patterns with various sizes and heights.

describing the width of the platelets' edges was found to explain the slope of experimental PSD at high frequencies.
